The Sinos River Watershed and Microplastic Pollution: current status, presence evaluation and perspectives

Jenifer Panizzon*¹, Marina Zimmer Correa¹, Günther Gehlen¹, Paula Sobral² and Vanusca Dalosto Jahno¹

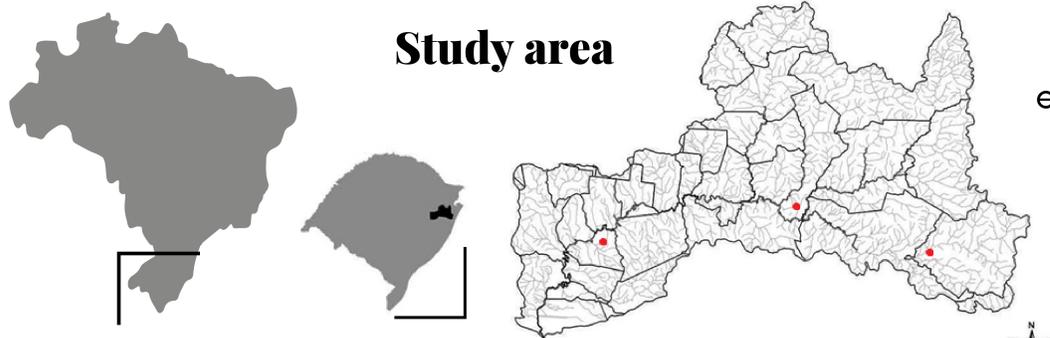
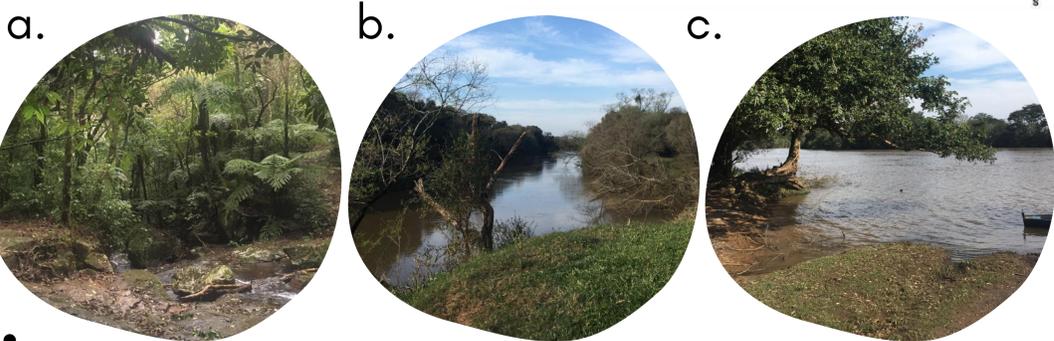
Study area

The basin is subdivided into three sections (● from right to left): **upper**, **middle**, and **lower**.

Surface water and sediment samples were collected at sites in Caraá (upper a.), Parobé (middle b.), and São Leopoldo (lower c.) sections along the riverbank.
